**NPDES
Inspection Report**

**Sierra Pacific Industries
(NPDES Permit #: WAR007765)**

Burlington, Washington

September 4, 2015 and September 14, 2015

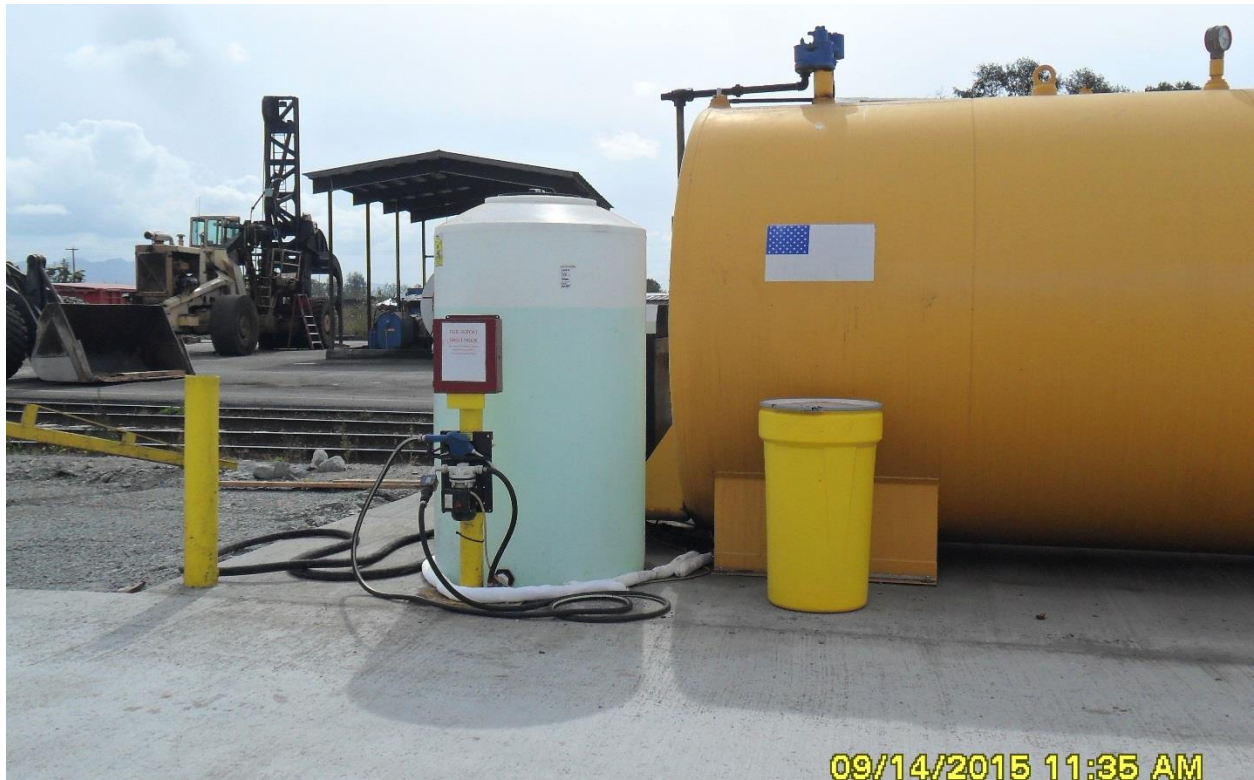
At the time of the inspection, we conducted a facility tour including areas that had chemical storage. Located in the vicinity of the truck shop, was a container of what facility representatives identified as urea. At the time of inspection, this container did not have secondary containment.

Photograph 1 (SAM_2090): View of the urea container (translucent white tank) without secondary containment. This container is located just north of the truck shop, in the southeast corner of the property.

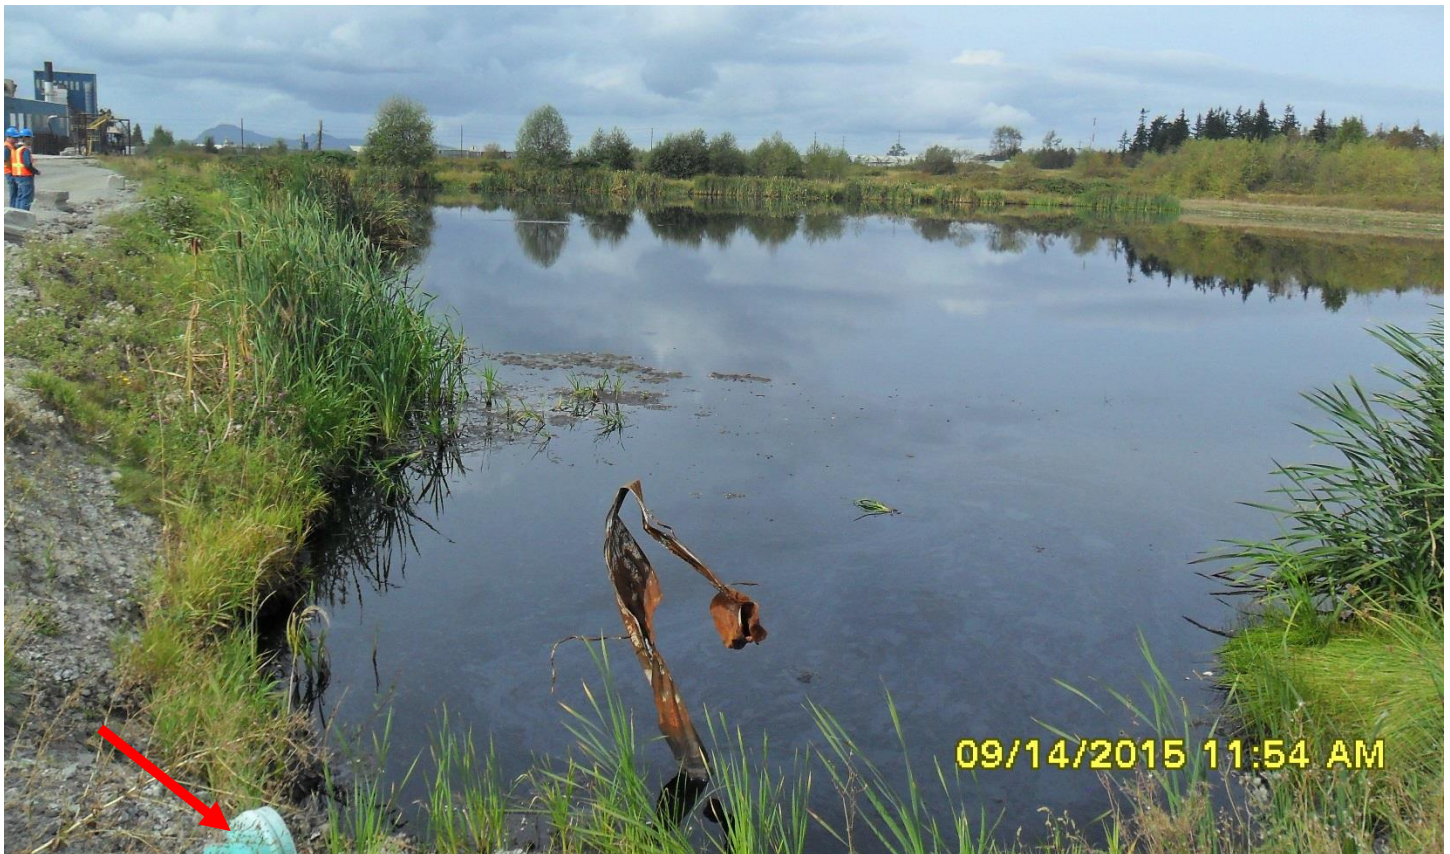
The primary drainage area drains almost the entire facility. Drainage from the facility is routed north to a stormwater detention pond. Stormwater entering this pond then flows directly south via an underground pipeline to Indian Slough at discharge point DP1. See Attachment A and photograph 6 in Attachment B of this report for a detailed view of DP1.

Photograph 2 (SAM_2093): View of the stormwater detention pond located on the north side of the property. A majority of the stormwater from the property is routed to this pond. One inlet can be seen on the bottom right corner of the photograph, indicated by the red arrow.

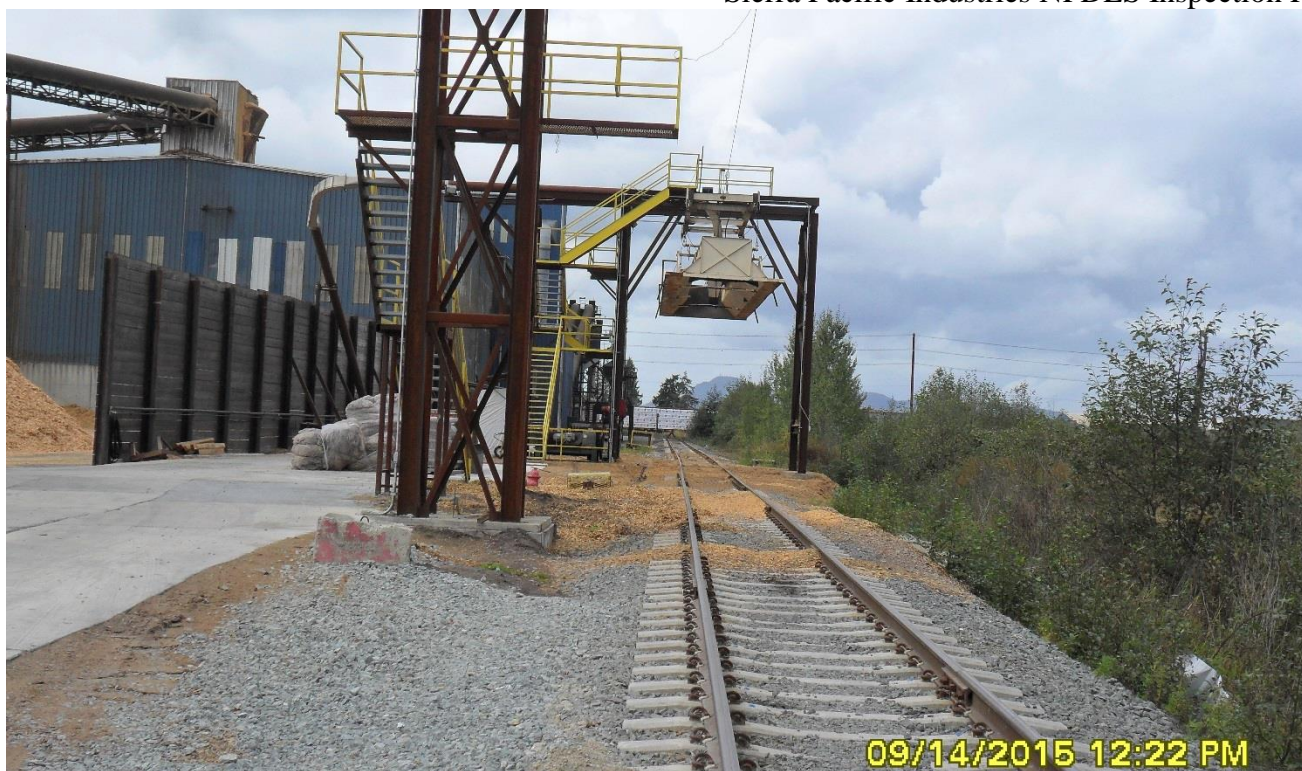
At the time of the inspection, we conducted a field tour including the chip loading area on the north side of the facility. See Attachment A for the location of this area. This chip loading area is located adjacent to drainage ditch 19, which discharges into Indian Slough. At this time, I saw chip debris scattered on the ground, adjacent to drainage ditch 19. See photographs 3 and 4 in Attachment B for views of this area. This area did contain silt fencing down gradient of the loading area and uphill of drainage ditch 19, however, this fencing was not maintained as it was pushed down by the debris.

Photograph 3 (SAM_2097): Overview of the chip loading area, located on the north side of the facility.

Following the inspection, Mr. Hamar provided photographs of additional barriers installed between the chip loading area and drainage ditch 19 to prevent debris from entering the ditch. See Attachment H for these photographs provided by the facility.

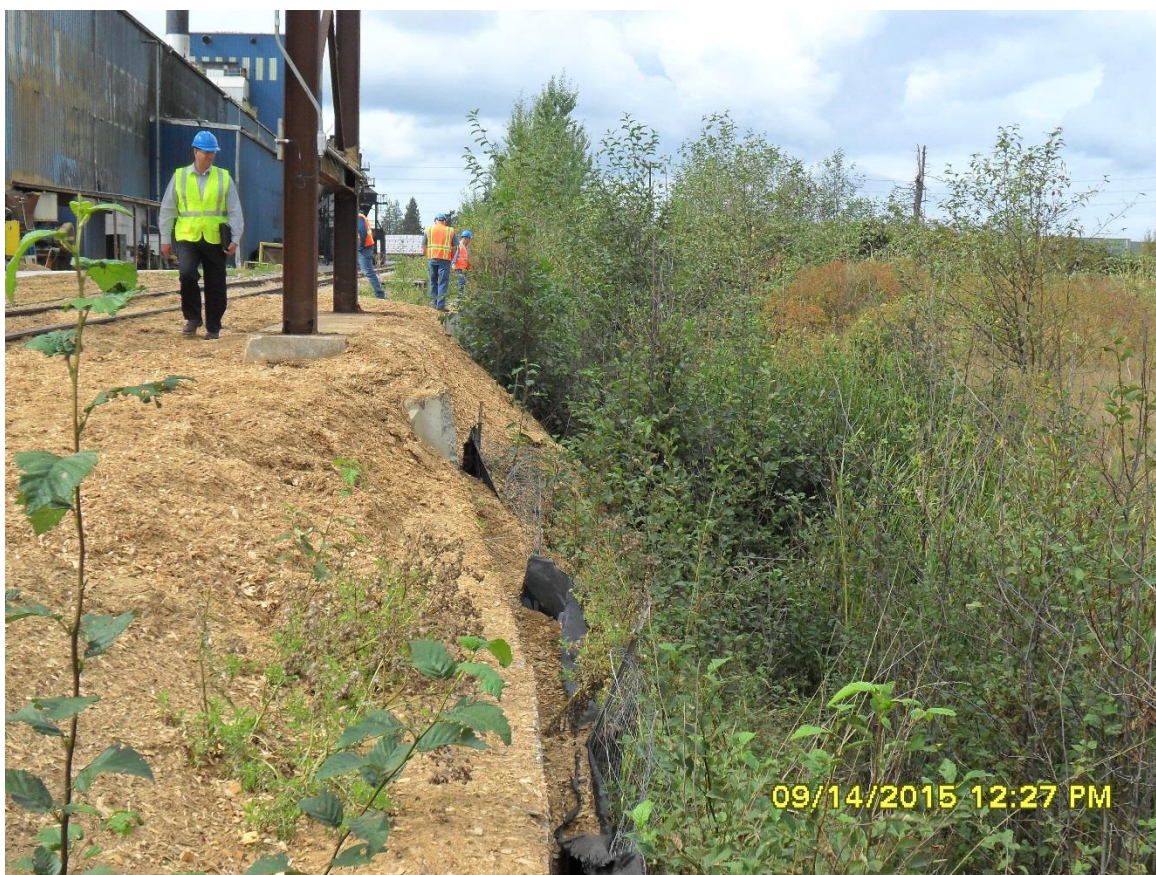
Photograph 4 (SAM_2098): View of the chip debris observed from chip loading activities. Drainage ditch 19 intersects this area at the approximate location of the persons wearing the orange safety vests in the background.

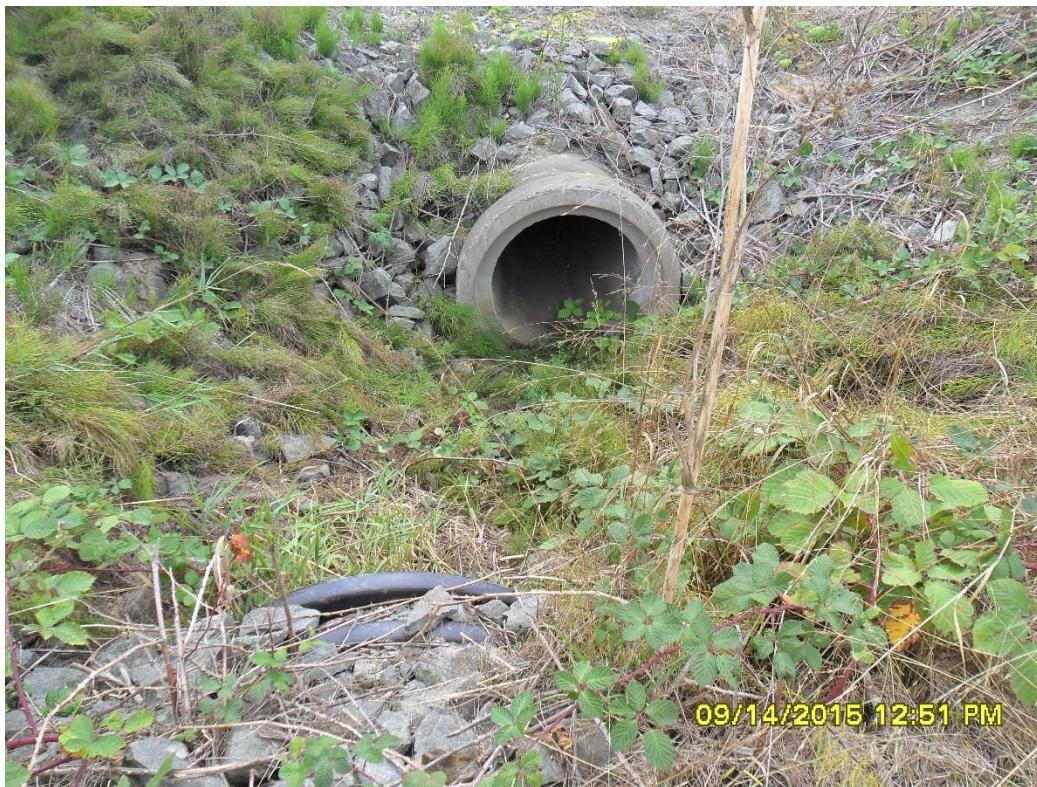
The second drainage area at this facility is for a small section of McFarland Road at the south side of the facility. This is the main entrance road to the facility that maintains truck, forklift and employee vehicle traffic. This drainage area collects stormwater runoff from a portion of McFarland Road and routes this drainage to Indian Slough at discharge point DP2. See photograph 5 in Attachment B of this report for a detailed view of DP2.

According to Mr. Hamar, stormwater sample collection occurs at two discharge locations, DP-1 and DP-2. See Attachment A for the location of these discharges. As mentioned earlier in this report, DP-2 is the point at which water from drainage ditch 19 and stormwater runoff from a portion McFarland Road comeingle and discharge into Indian Slough. Mr. Hamar indicated that when stormwater samples are collected at DP-2 the sample would be of this comingled water. This information indicates that the samples collected at this location do not solely reflect the impact of industrial activity occurring in the drainage area for DP-2.

Photograph 5 (SAM_2103): View of the sample collection point at outfall DP2. This outfall drains stormwater from a portion of McFarland Road and the water collected in drainage ditch 19. At this point, stormwater from McFarland Road and water in drainage ditch 19 are comingled.

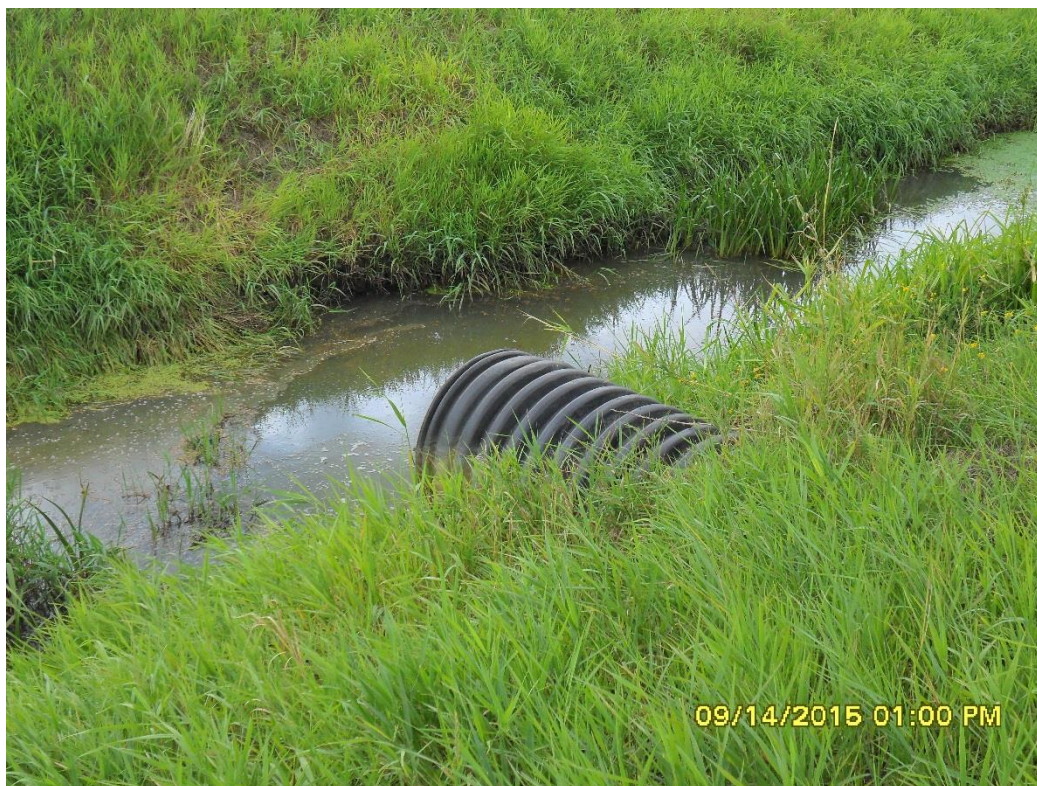
Photograph 6 (SAM_2104): View of the sample collection point at outfall DP1. This outfall drains stormwater routed to and collected in the stormwater detention pond. Indian Slough is seen here in the background.
